1394 OHCI

DCAM Versions

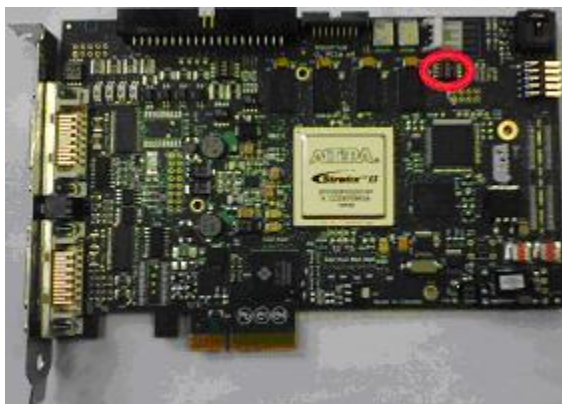
Older motherboards and/or some PCI Express 2.0 slots (Ex. - Dell T5400/T7400 x16 slots) may have BIOS incompatibilities with the Xcelera card. This usually presents itself where the PCIe slot in which the board is installed cannot initialize and a BIOS error message is shown, or the PC will not boot at all. In either case, the cause can be related to unexpected PCIe bus reset negotiations with the BIOS/motherboard and the Xcelera. A possible method to circumvent this issue is to set DIPSW3-2 to ON (right position) before installing the card into the PC. This causes the Xcelera to ignore PCIe reset requests which normally allows the card/PC to boot properly. The side effect is when the board is configured in this manner, if the board has never been initialized with the current drivers/firmware yet, a firmware flash may be attempted silently to the board after Windows startup or just after the first PnP device detection sequence. After flashing is made, the board may still be inoperable – you can know it if your DCAM-API host application fails to initialize and detect your camera after approximately 5 minutes after startup. If this should happen, a manual Windows restart should correct the issue, and the board will continue to operate properly in the installed slot. The DIPSW3 bank is located on the board at the red circled location:

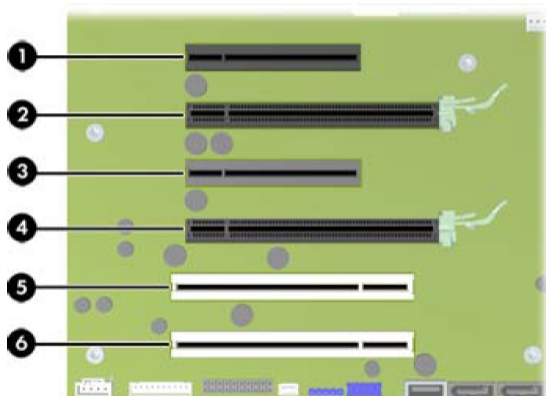
Identifying expansion card slots

The following figure identifies workstation expansion card slots.

The following table describes the workstation PCIe card slots.

Slot	Type	Slot power (Maximum)
1	PCIe2 - x8(4)	25W
2	PCIe2 - x16	75W
3	PCIe - x8(4)	25W
4	PCIe2 - x16	75W

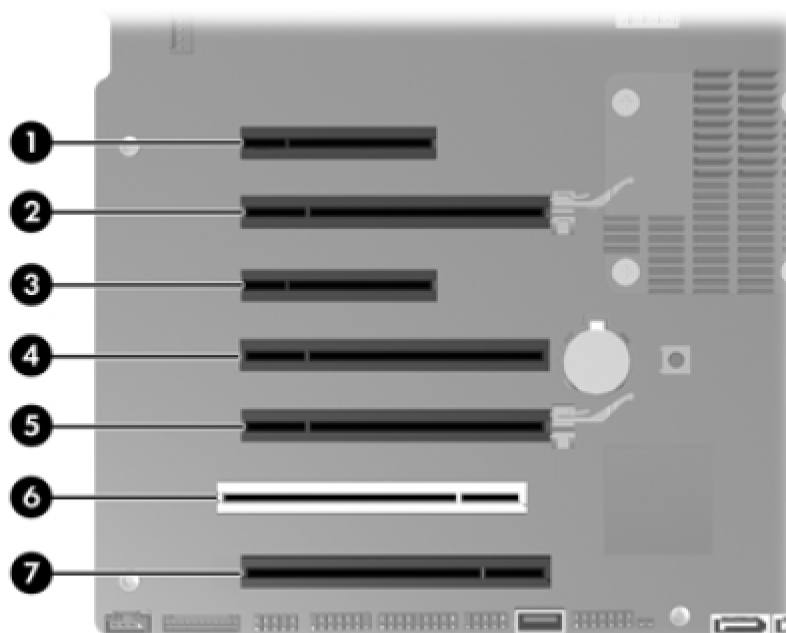
Identifying expansion card slots

The following figure identifies workstation expansion card slots.

The following table describes the workstation expansion card slots.

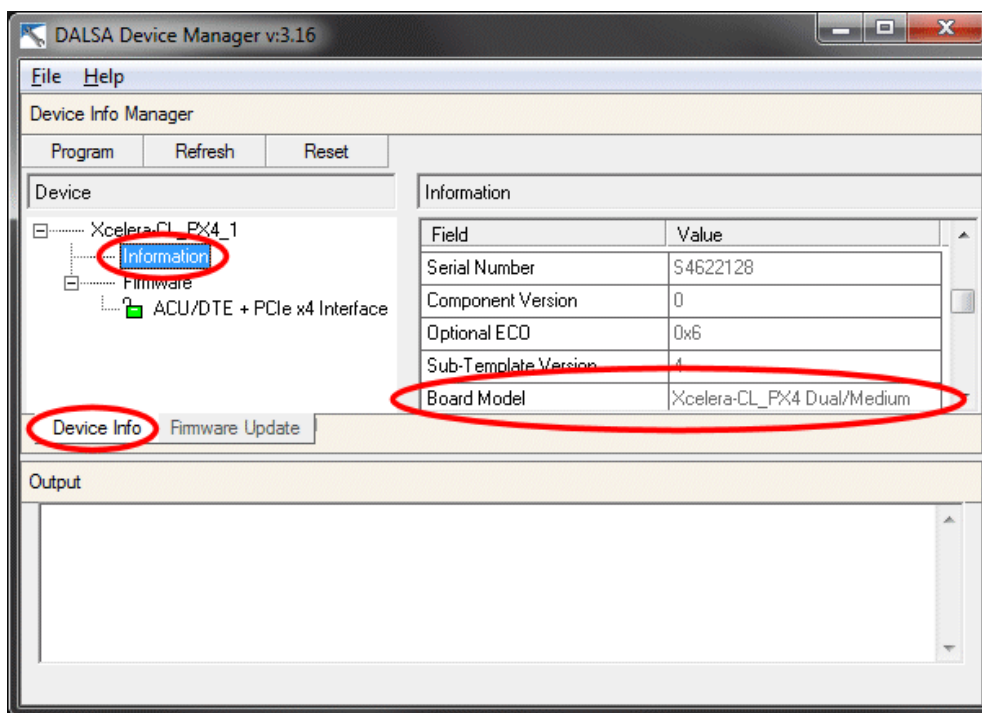
4. Press the Device Info tab, then click Information, scroll the right pane to show the Board Model and take note of it:
